Air Accidents Investigation Branch

**Report on the accident to
Aerospatiale SA365N, registration G-BLUN
near the North Morecambe gas platform
Morecambe Bay
on 27 December 2006**

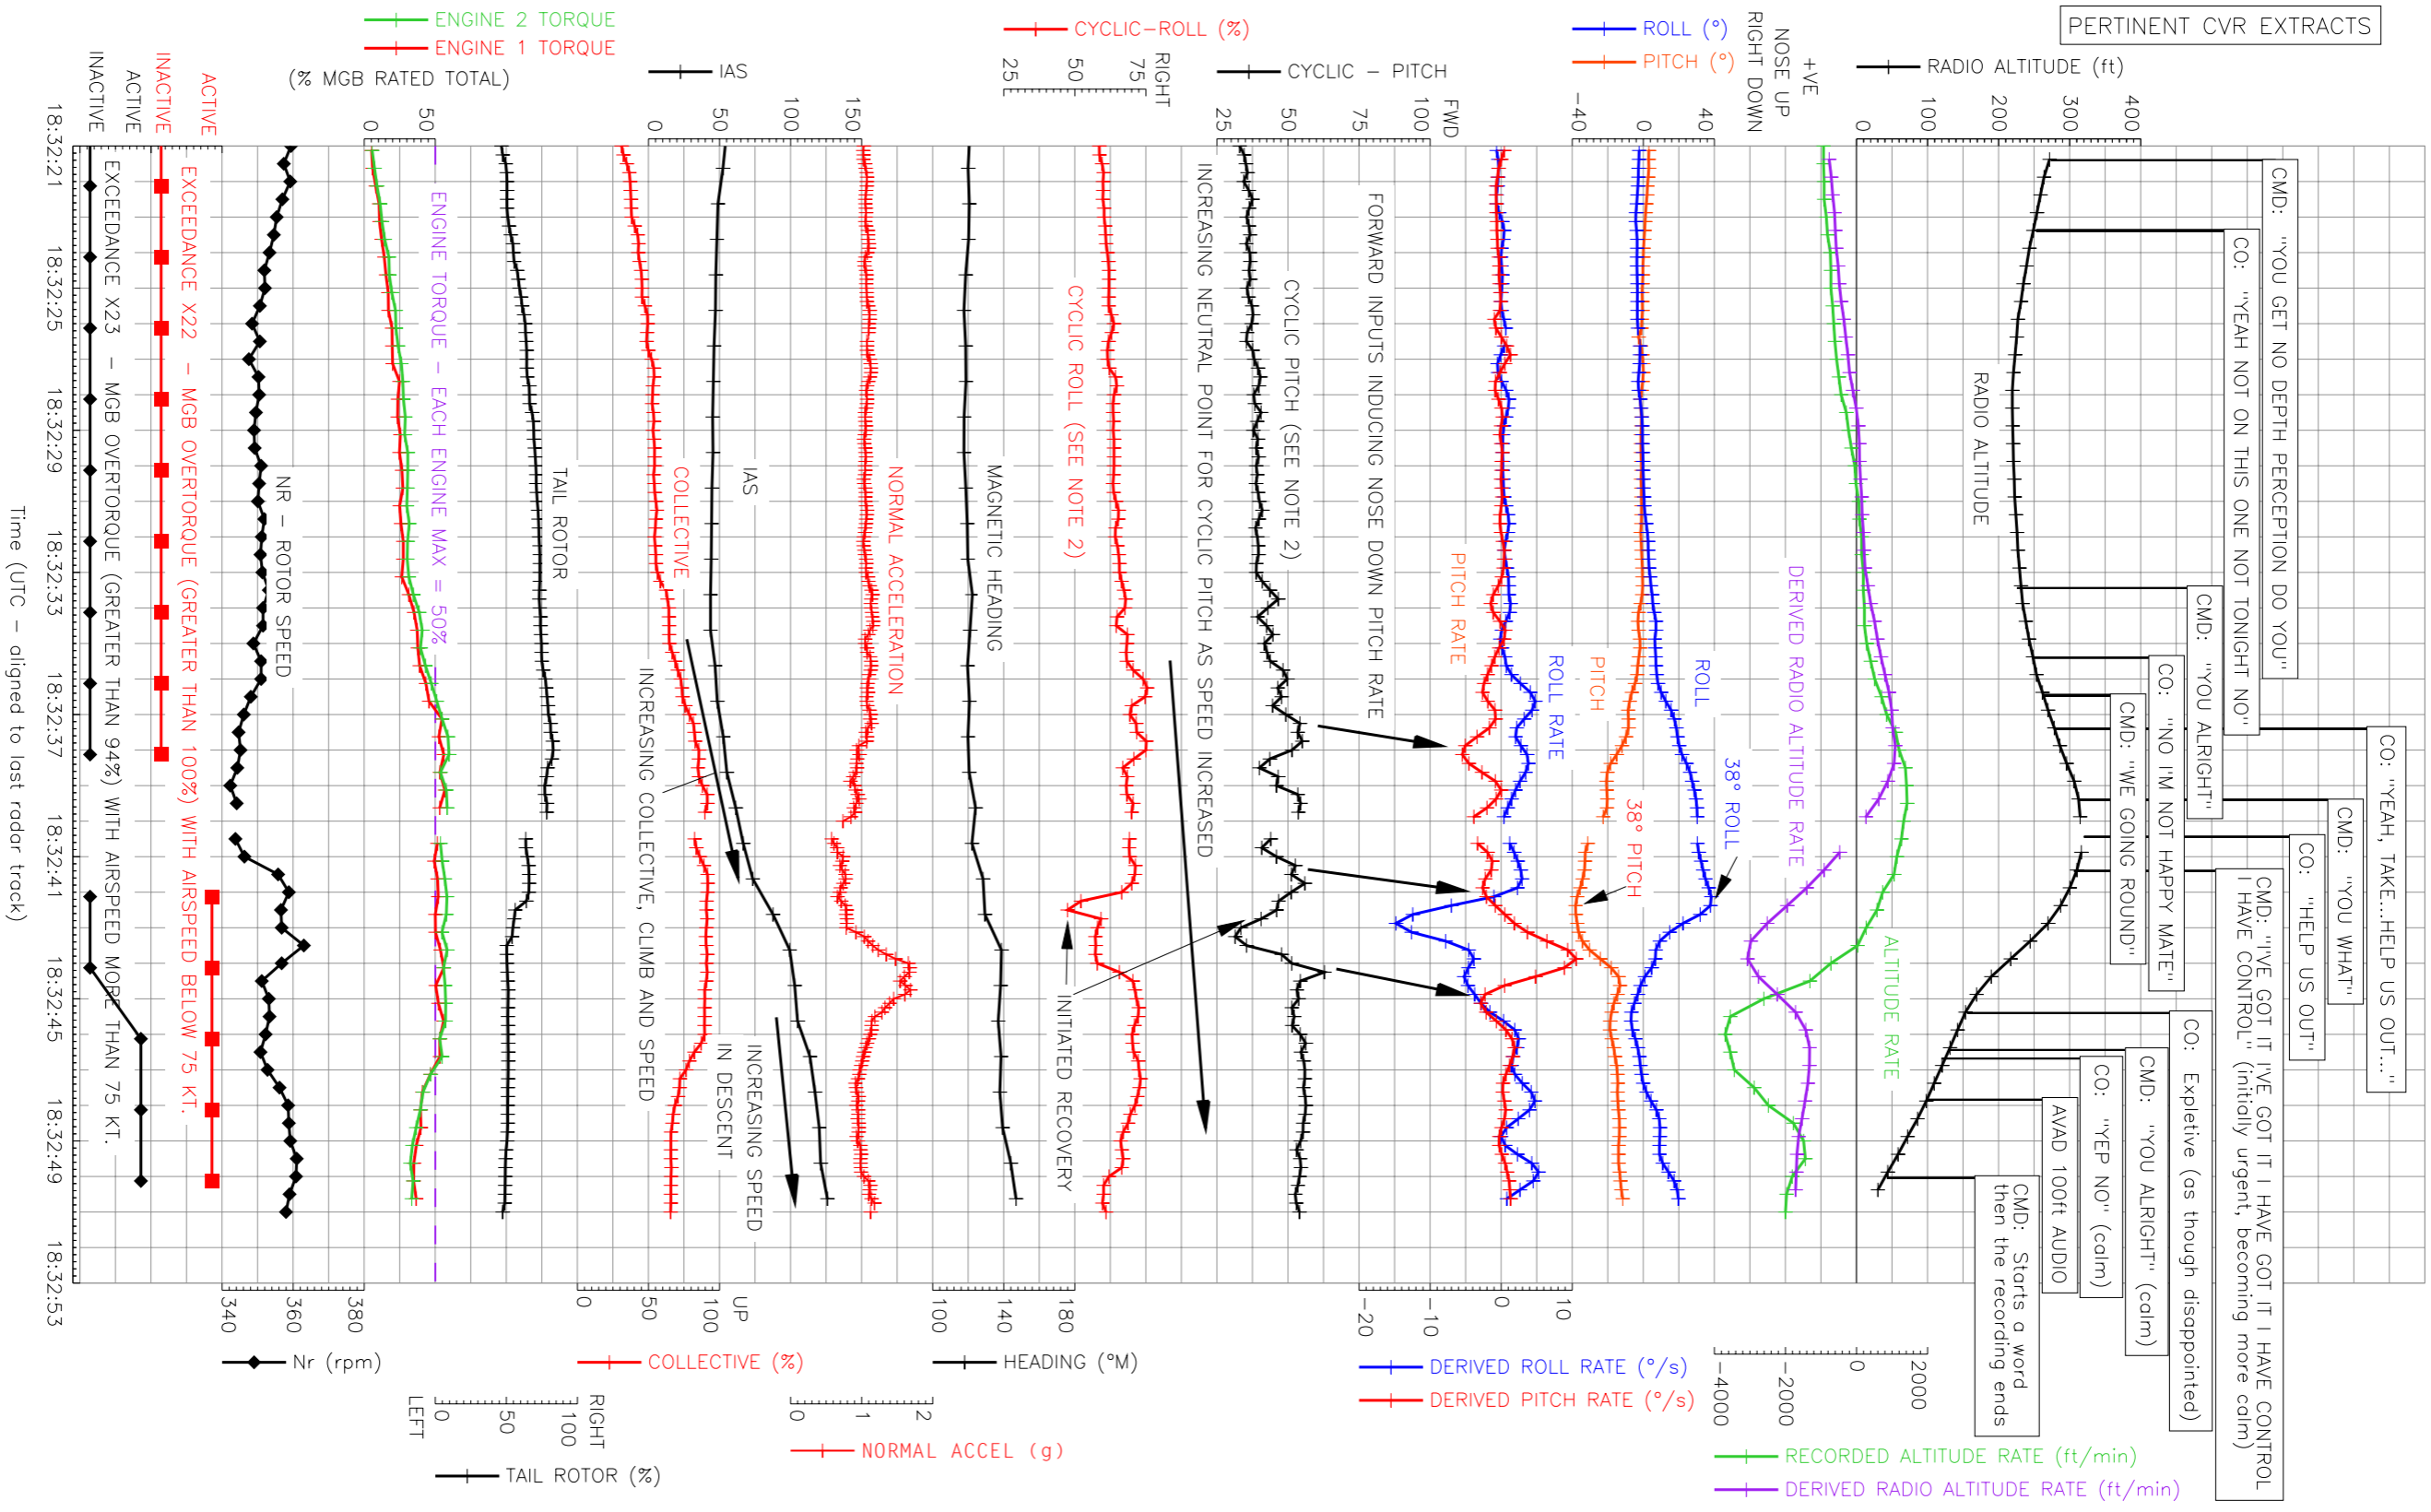
Figure 2

NOTE: 1) SOME DATA WAS LOST DUE TO CORROSION OF THE MAGNETIC TAPE DUE TO CONTAMINATION WITH SEA WATER. THIS IS INDICATED BY THE LACK OF A SAMPLE POINT
 2) THE CYCLIC POSITIONS FOR TRIMMED FLIGHT ARE NOT 50% BUT VARY WITH OTHER PARAMETERS

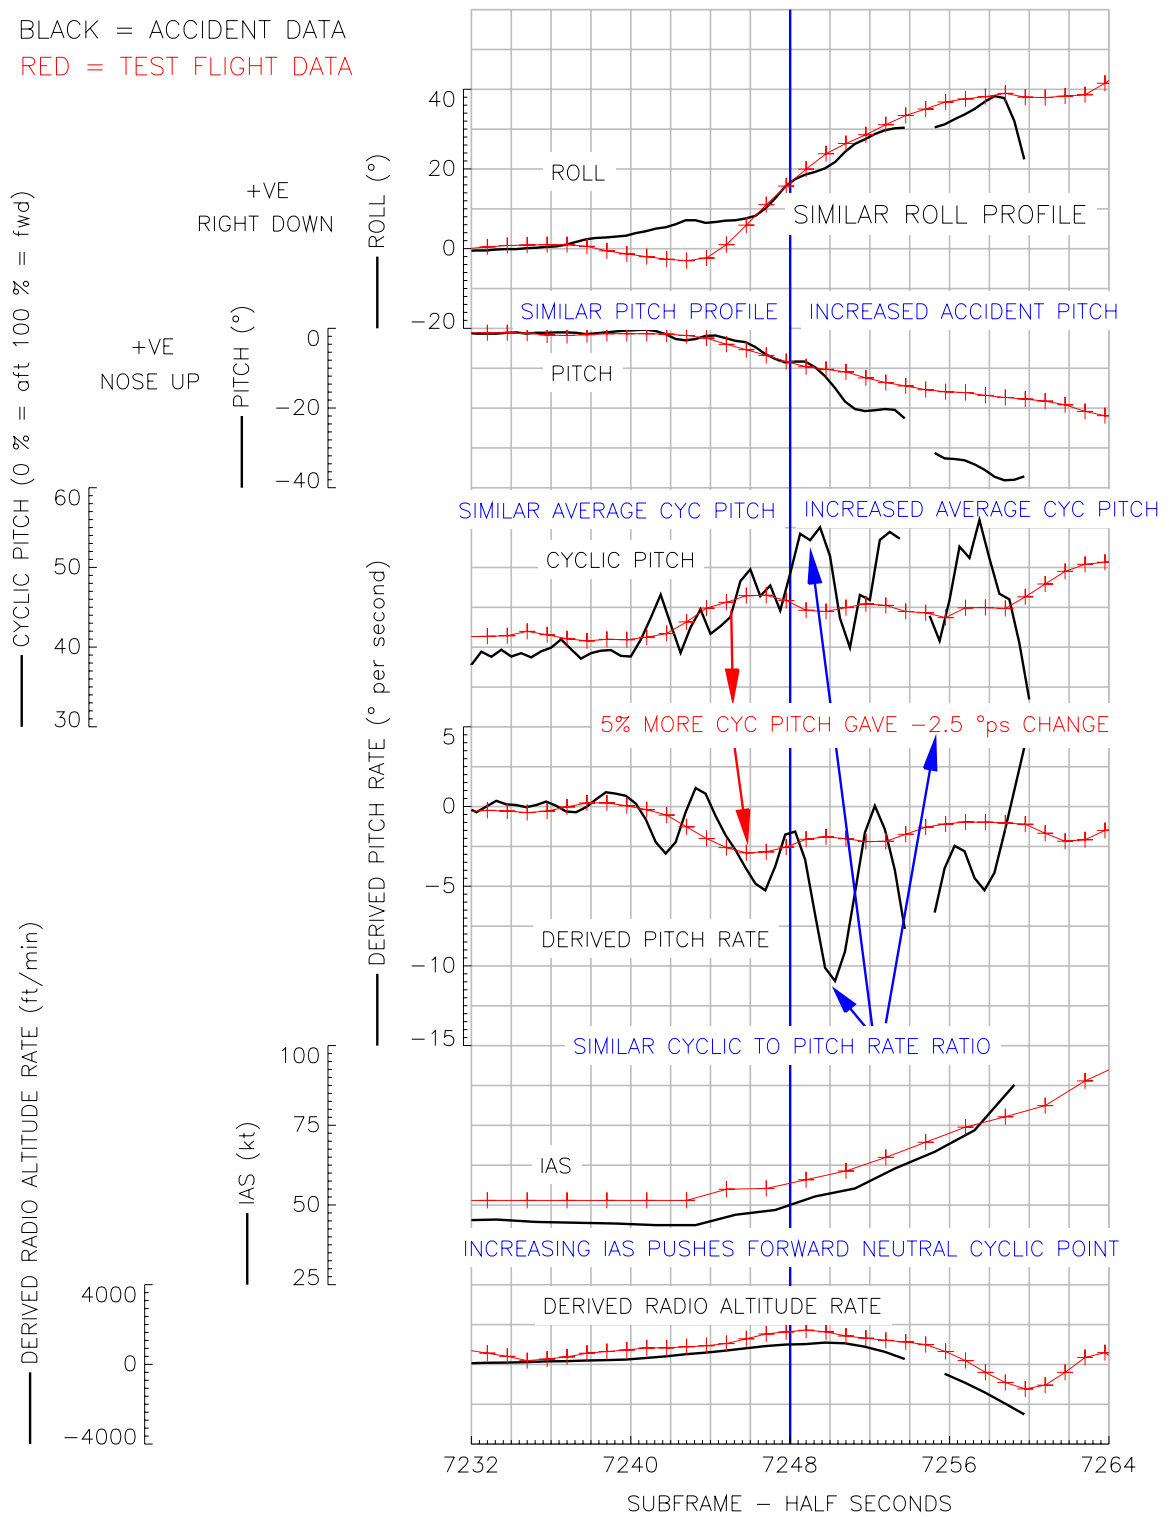
Figure 5

The flight test data was used to establish a broad relationship between the cyclic pitch inputs and the associated pitch responses of the helicopter, under steady state conditions. This was to assess whether there was any significant difference between the behaviour of the test helicopter and that of the accident helicopter during its last few seconds, when it was in an approximately stable descent. The flight test data showed that for a given pitch attitude relative to the vertical flight path of the helicopter, more forward cyclic pitch inputs are required at higher speeds. The recorded vertical path, speed, pitch attitude and cyclic pitch input during the last few seconds of the accident flight were consistent with the relationship between these parameters drawn from the data recorded during the flight test.

Comparison of pitch and roll parameters of the accident flight with the flight test data

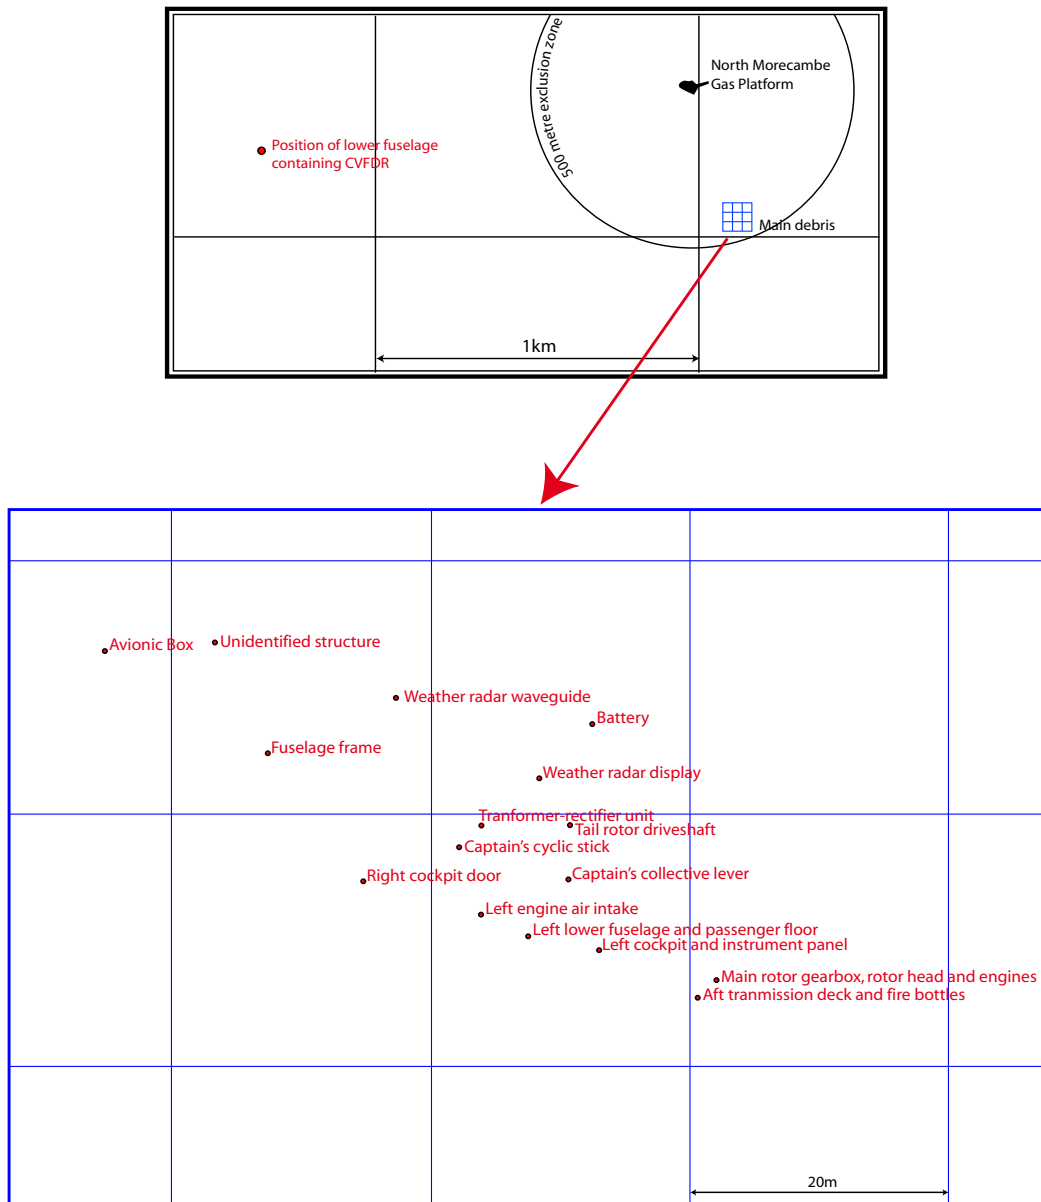
The diving support vessel confirmed that the sonar contacts were indeed substantial pieces of G-BLUN, lying amongst a field of smaller debris (see Figure 6). The most substantial piece was a section of transmission deck with the main rotor gearbox, main rotor head with varying lengths of blade still attached, and the engines. The engine mounts were disrupted but, when the gearbox was raised on 10 January 2007, the engines remained attached by fuel pipes, wiring looms etc and were also recovered. Throughout this period, attempts were made to locate precisely the locator beacon using detection equipment mounted on a Remotely Operated Vehicle (ROV); however, this was not successful.

Bad weather delayed further salvage attempts but eventually all the parts depicted in Figure 6 were recovered, plus a number of smaller items. Meanwhile, slightly improved conditions allowed an accurate location of the CVFDR to be completed. It was recovered on 16 January 2007, still within its rack in the baggage compartment, located in a large intact section of the lower rear fuselage. This section of the structure also housed the main landing gears, which were locked in the extended position. As can be seen from Figure 6, it was found about 1.3 km west-north-west of the main debris field and was the

Map of debris field showing main identifiable wreckage and (inset) location of debris field relative to North Morecambe gas rig

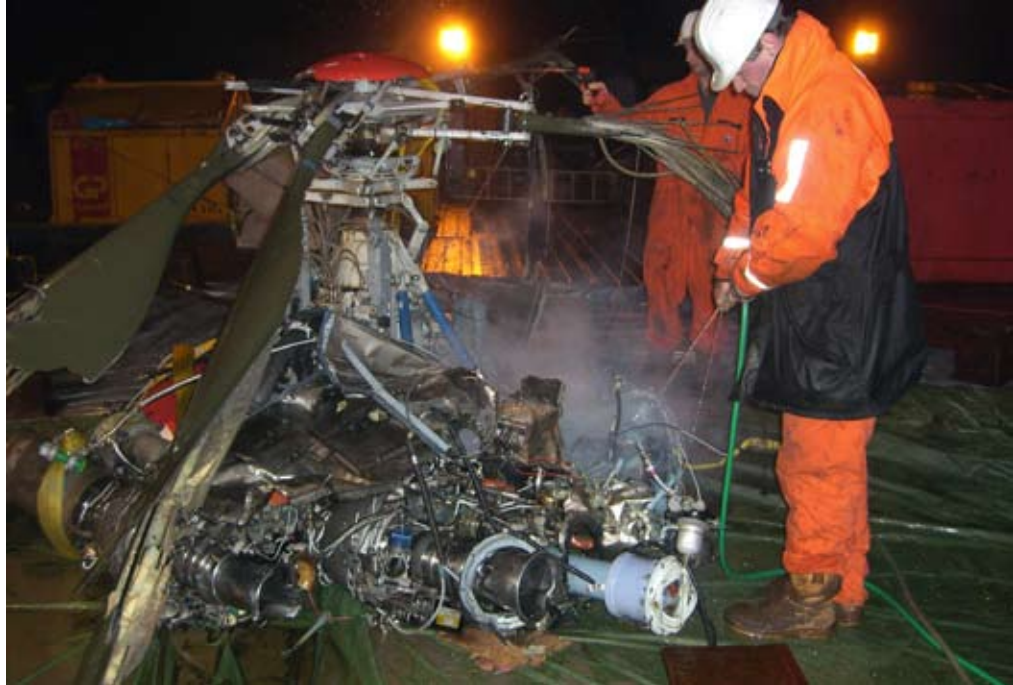
Figure 7

The main rotor gearbox, together with the rotor head and the remains of the rotor blades, was recovered still attached to the transmission deck. Damage to the three gearbox support struts indicated that the transmission system had been subject to a significant overtorque loading, as might be experienced through, for example, a main rotor strike on water. The inboard sections of the four rotor blades were still attached to the rotor head, which had been severely damaged; all of the elastomeric bearings had failed allowing the blade attachment beams to separate from the outboard ends of the rotor head star

(see Figure 7). Although severely distorted, all of the blade control linkages remained connected. After removal of the rotor blades, the transmission deck, gearbox and rotor head were shipped to the manufacturer in France for disassembly under AAIB supervision.

Main rotor head

During disassembly, impact marks observed on the lower gearbox suspension torque stops indicated that the transmission system had been subject to a very high torque load, consistent with the rotor system striking the water whilst under moderate to high power. Prior to disassembly of the transmission system the gearbox driven hydraulic pumps, used to power the main and tail rotor actuators, were removed and examined. The presence of corrosion products prevented the units being bench-tested; however, disassembly confirmed that they had not suffered any internal failure and after clearing they could be rotated freely. The rotor head hydraulic actuators were also removed for testing and examination by their manufacturer under AAIB supervision. Examination of the components of the main rotor gearbox confirmed that there was no evidence of any pre-existing defects or failures within the system.

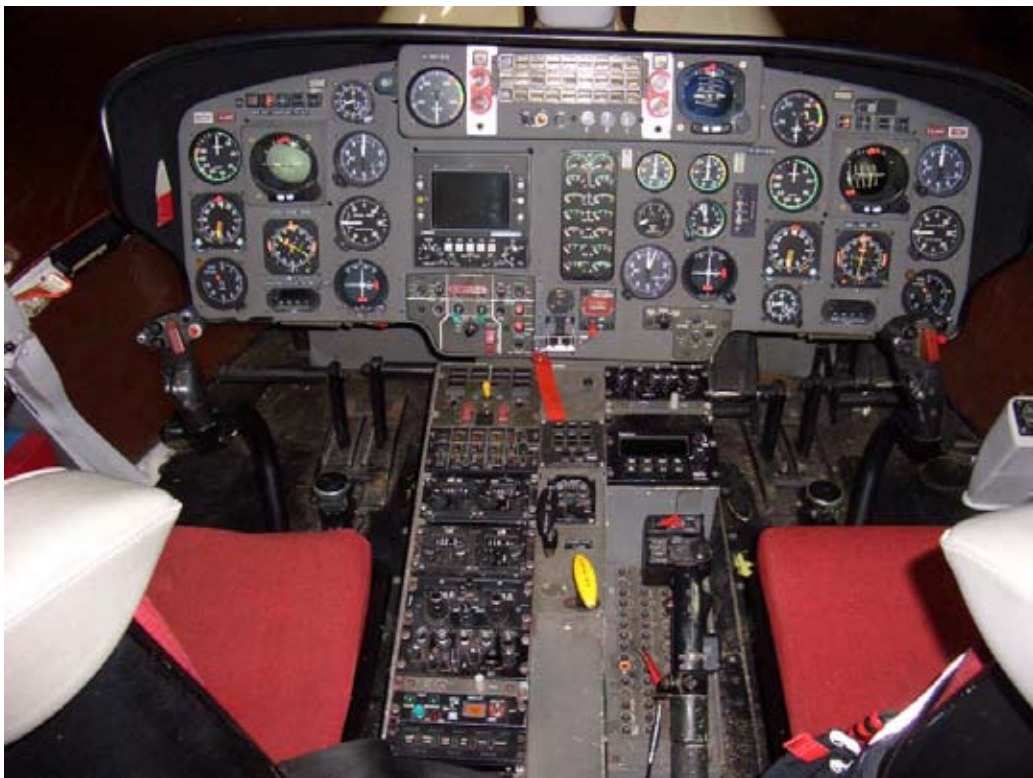
The cockpit was assessed throughout both flights from the left hand seat (LHS) as this had been the position of the handling pilot of G-BLUN. The cockpit was equipped with flying instruments on both LHS and RHS stations. It was noted that the layout of instruments differed between LHS and RHS panels. In particular in each case the rad alt was positioned at the bottom outboard corner of the panel. Additionally it was noted that the engine/power instruments were biased towards the right hand side of the central panel. Although a duplicate Nr tachometer had been installed in the Field of Regard (FOR) of the LHS pilot the aircraft's only torquemeter was a small 4cm instrument fitted at the right hand side of the central panel and was well outside the FOR of the LHS occupant.

Fig 1. AS 365N Cockpit

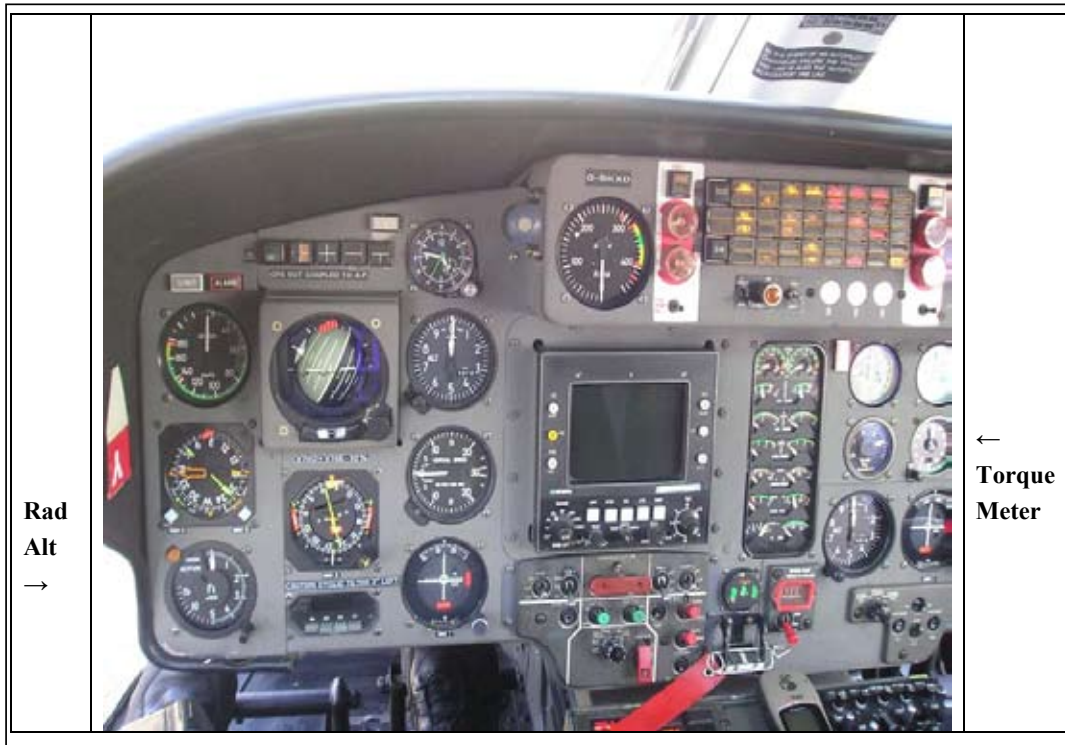
The small torquemeter was difficult to read and was positioned well outside the LHS occupant's normal FOR. The higher power figures required to hover or go-around were situated in the arc from 6 o'clock to 10 o'clock and were partially obscured by the instrument bevel when viewed cross cockpit. It was not possible to conduct a normal scan on the LHS instruments while monitoring or setting torque. From the transcript of the accident aircraft CVR and in discussions

with the CHC TRE there did not appear to be any procedural method of the RHS occupant calling torques to assist the LHS handling pilot.

Fig 2. The LHS Panel and position of the torquemeter
