Air Accidents Investigation Branch

**Report on the accident to
Aerospatiale SA365N, registration G-BLUN
near the North Morecambe gas platform
Morecambe Bay
on 27 December 2006**

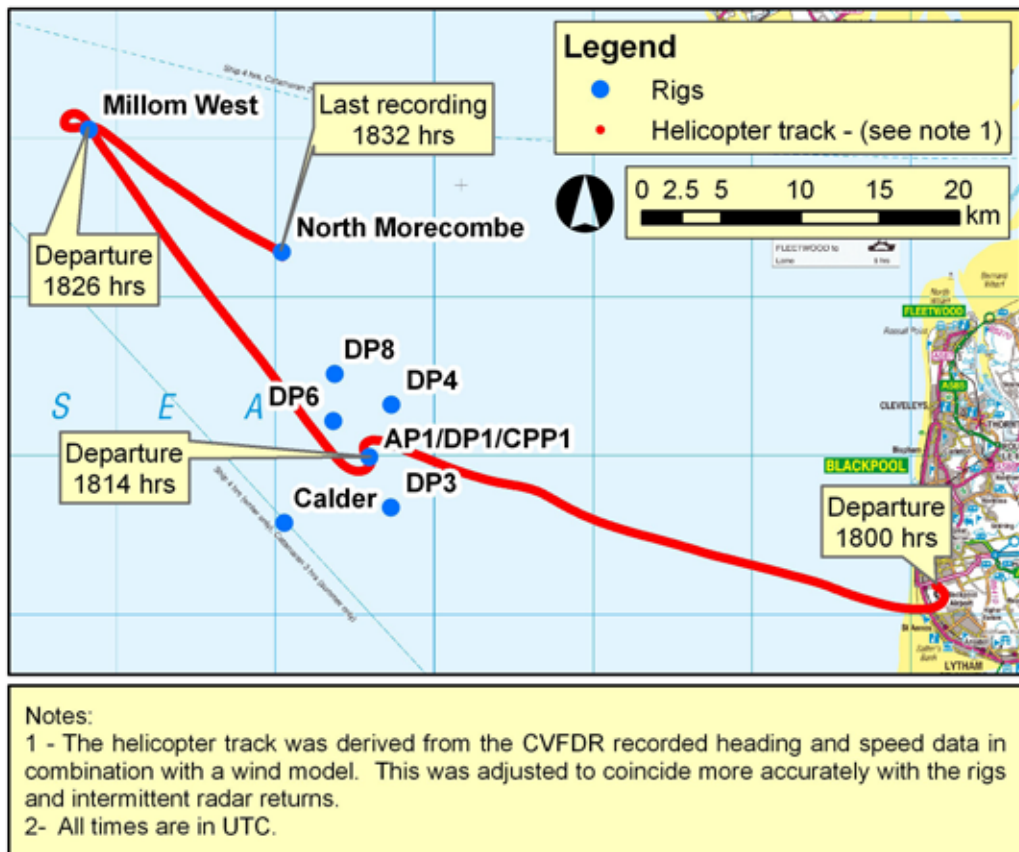
Figure 1

Overview of the helicopter movements

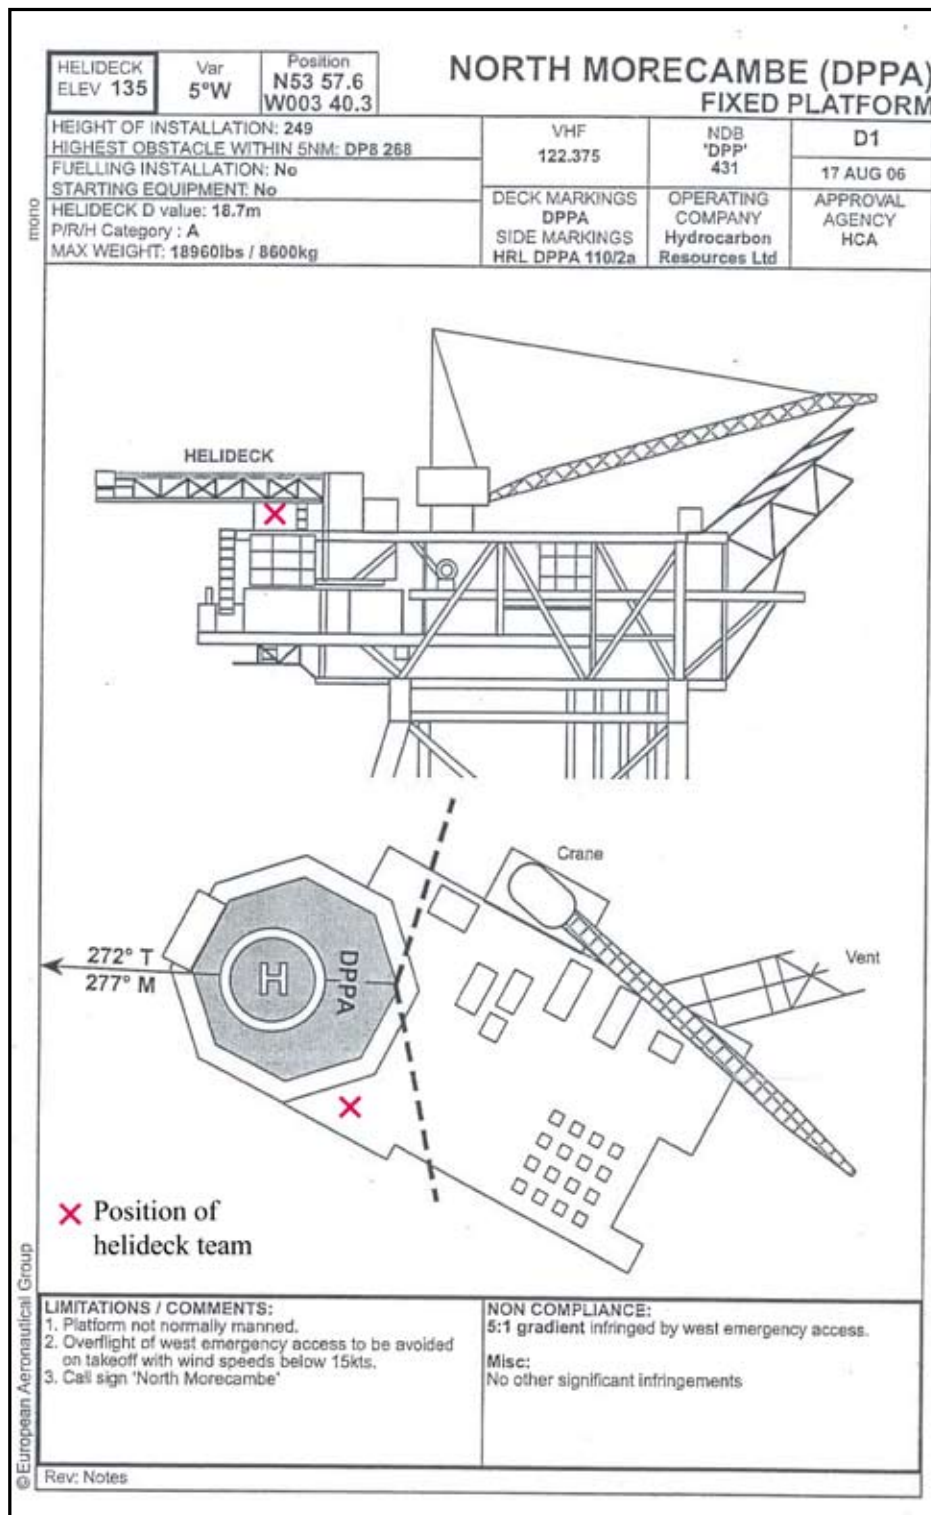
The three-man helideck team on the North Morecambe platform were positioned on the south-eastern edge of the helideck on steps, just below the level of the helideck (see Figure 3 for a diagram of the North Morecambe platform and the location of the helideck team). They were waiting for the helicopter to pick up a passenger and some freight. When they first saw the helicopter they estimated the visibility to be about 1,500 m. Everything appeared normal, and they assumed that the helicopter would complete a standard approach and landing on the platform. After what seemed to be a controlled turn to its right the helicopter appeared to initiate a go-around, although it seemed to be faster and closer to the platform than normal. The helicopter was then seen to bank slightly right as it continued past them, maintaining a steady rate of descent.

Location of helideck team

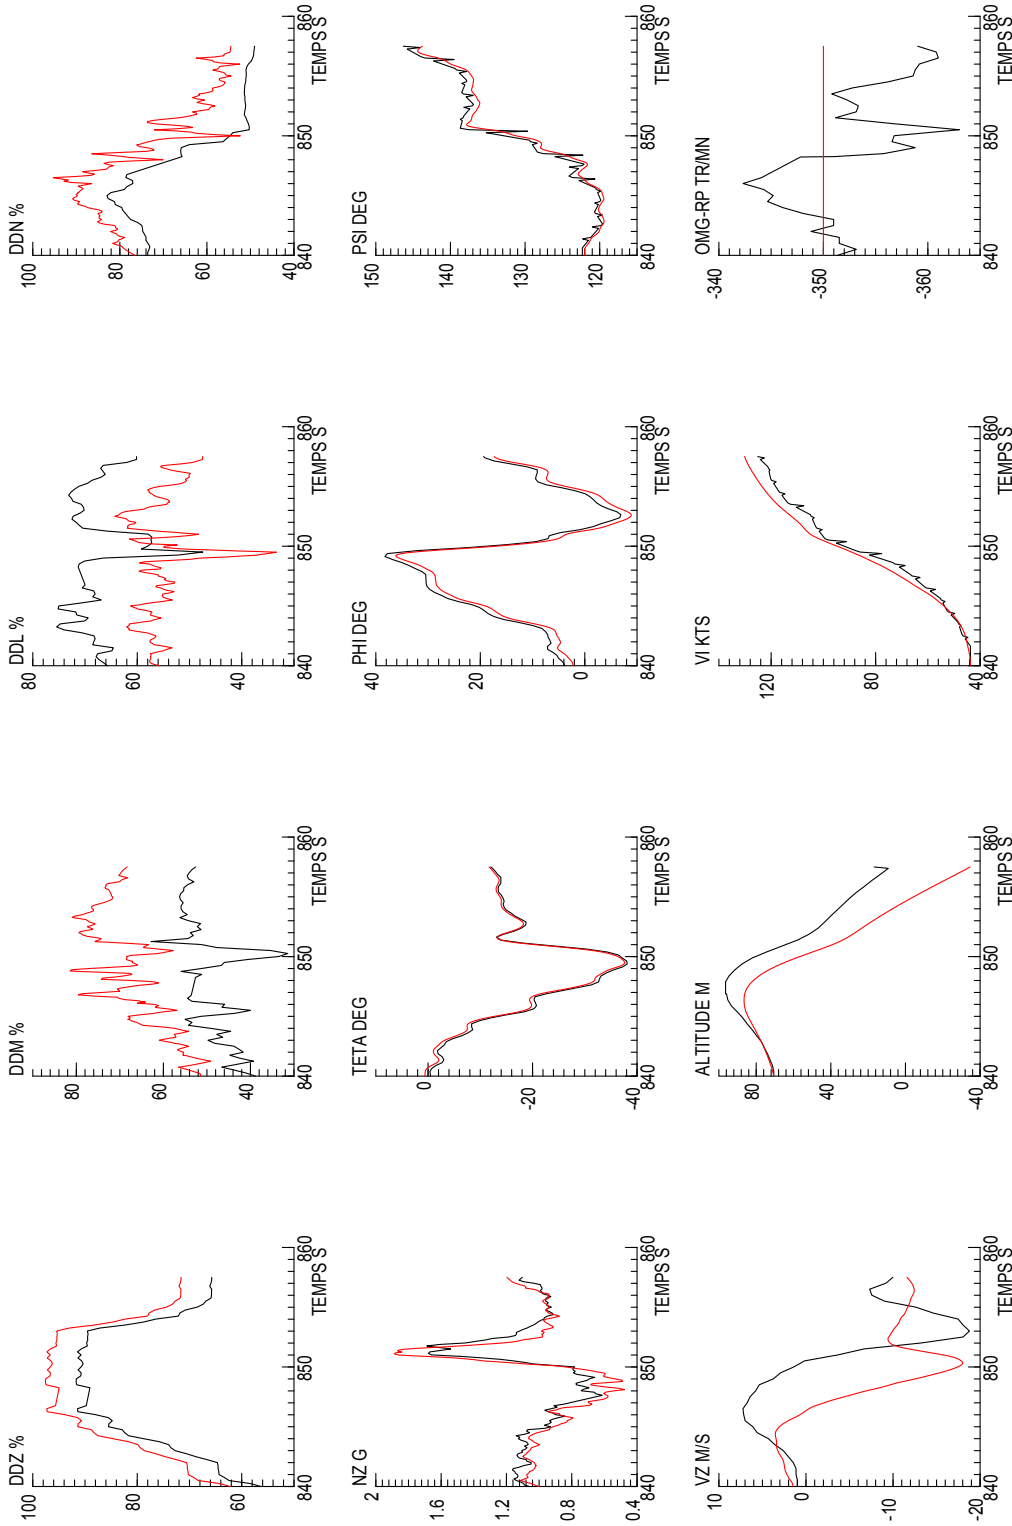
Simulation hypothesis

- Perfect engines (no variation on Nr)
- Atmospheric conditions: 0m at ISA -15°C
- Weight: 3863 kg
- Centre of gravity: 0.1m forward
- No wind simulated
- Simulation is initialised with flight data for speed (V_z and V_i)
- Sideslip: 6° on the right
- Collective stick has been forced to flight values
- Cyclic and tail rotor sticks have been imposed on speed angle variations

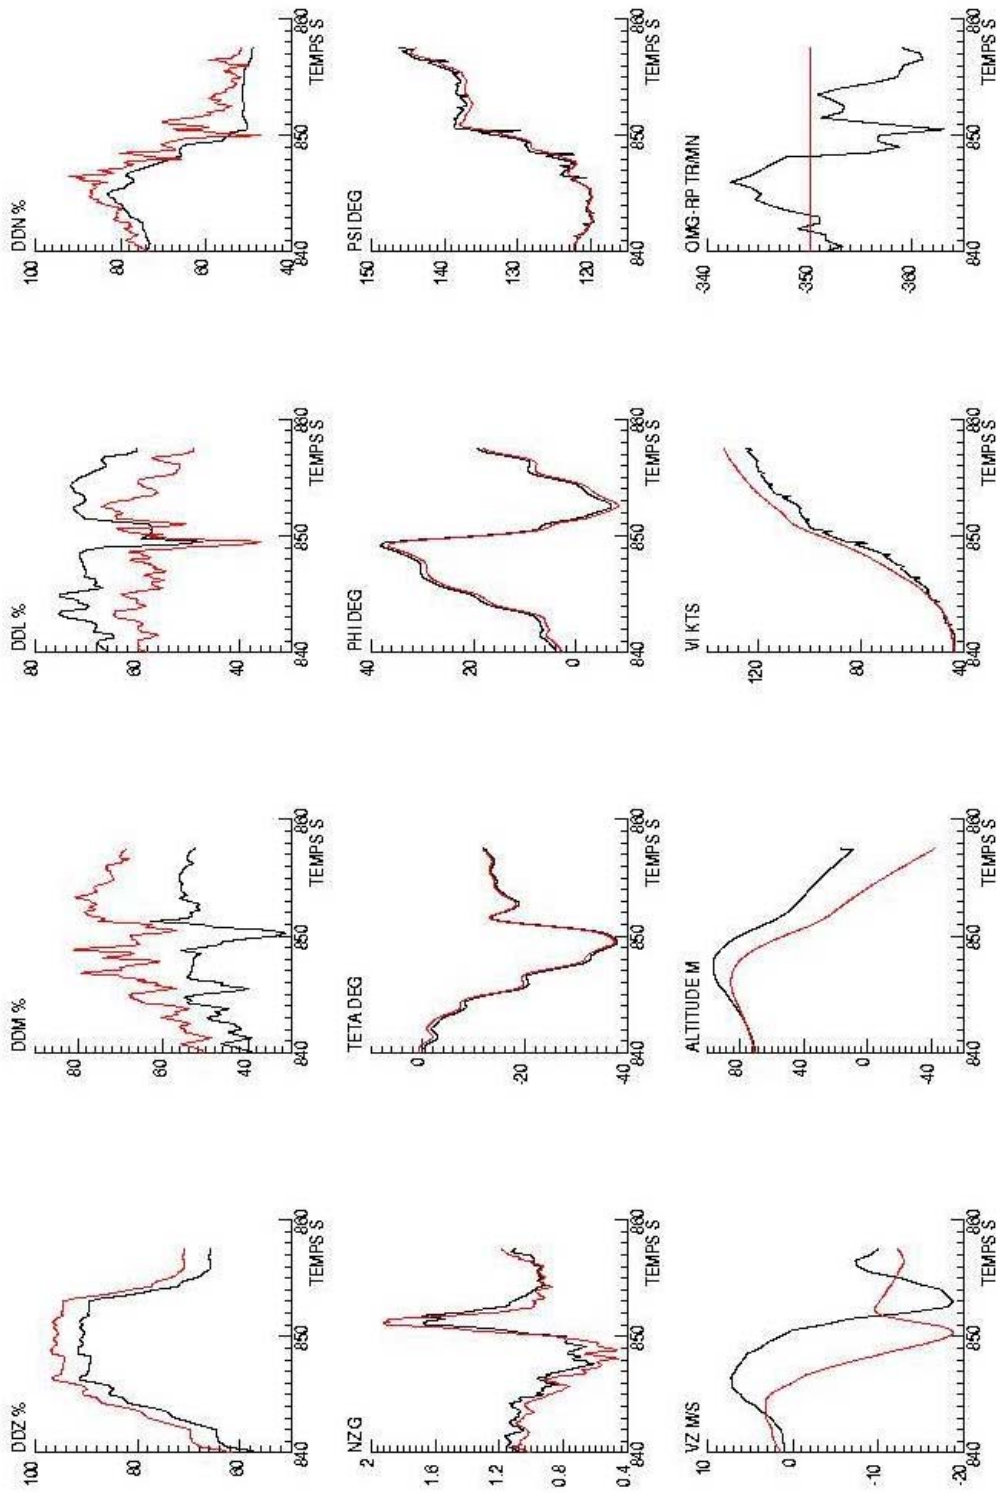
Simulation hypothesis

- Perfect engines (no variation on Nr)
- Atmospheric conditions: 70m at ISA -15°C
- Weight: 3700 kg
- Centre of gravity: 0.2m forward (3.8 m)
- 20 kt wind on the right rear
- Indicated speed: 43.688 kt
- Vertical speed: 2.5 m/s
- Sideslip: 6° on the right
- Collective stick has been forced to flight values
- Cyclic and tail rotor sticks have been imposed on speed angle variations

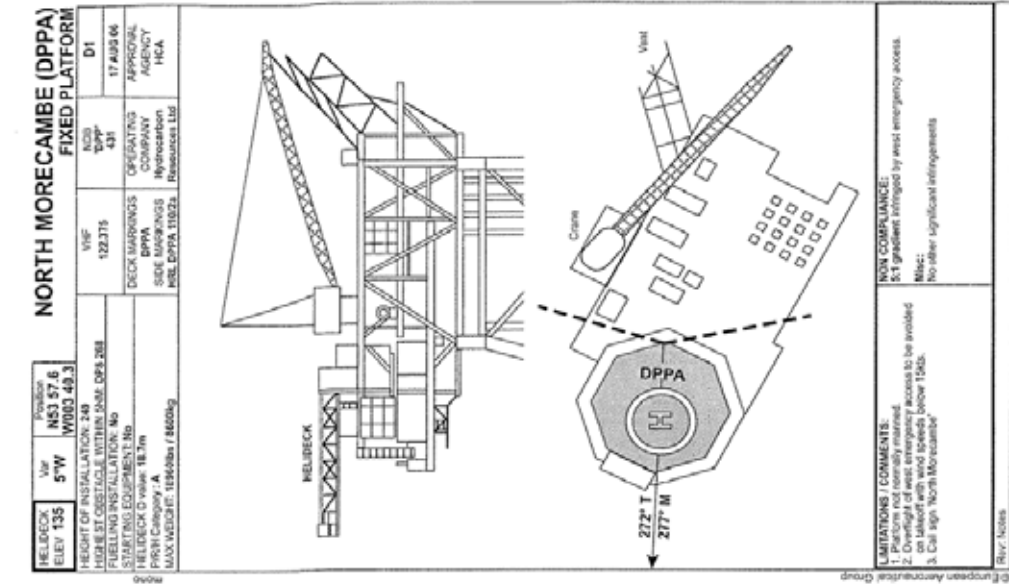
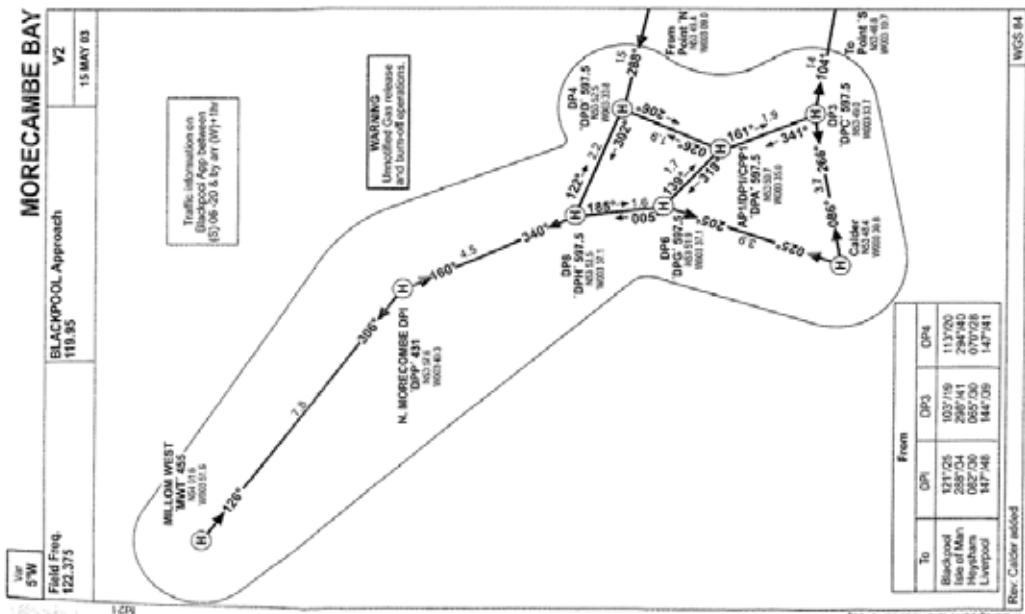
- The helipad at night gave insufficient cues to allow distance to be judged and without additional information from the weather radar or GPS the crew of G-BLUN would not have known the distance to run accurately.
- When the RHS pilot took control he would have had no visual cues from the platform.
